Water Compliance Inspection Report

***Alaska Pollutant Discharge Elimination System
(APDES) Inspection Report***

***WestRock Anchorage Recycling Center
APDES # AKR06AC72***

***Jon Klemesrud
Environmental Protection Agency, Region 10
Office of Compliance and Enforcement
Inspection and Enforcement Management Unit***

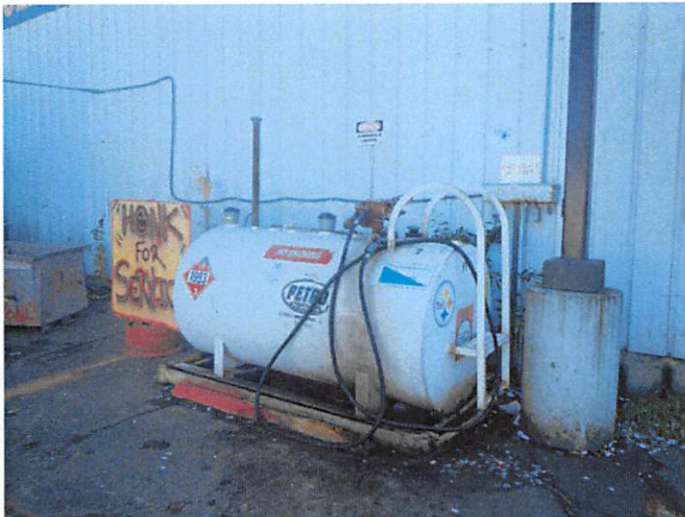
Photo #:01

Description: Facing south, photo of the 500-gallon diesel tank onsite. Camera Photo DSCN1171.

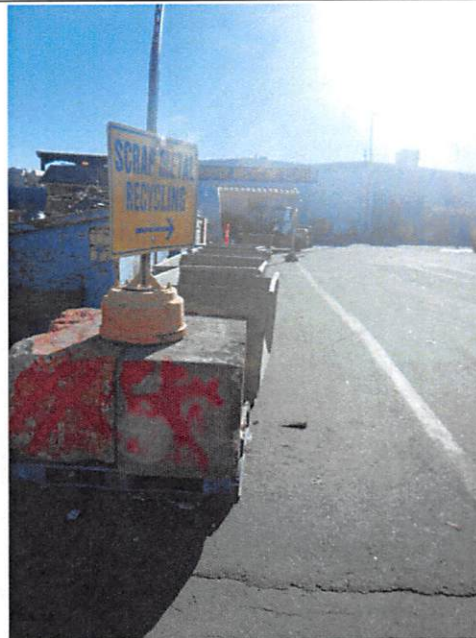
Photo #:02

Description: Facing south, photo taken near the entrance, showing a portion of the recyclable drop-off areas. Camera Photo DSCN1172.

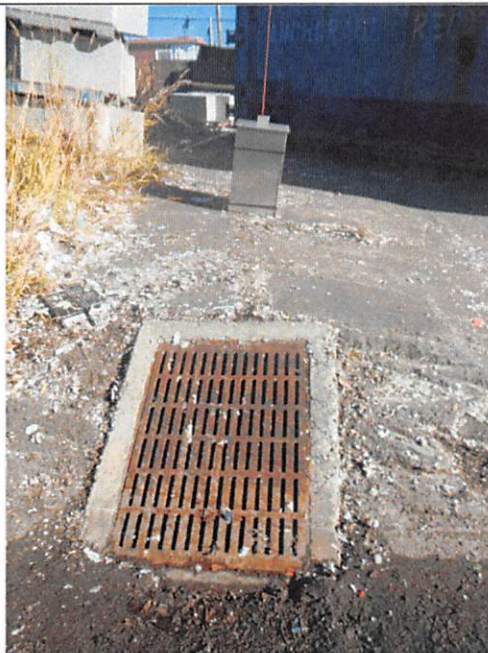
Photo #:03

At the time of the inspection, I observed multiple employees sweeping and cleaning up debris, however, debris was observed away from the recyclable storage piles and in many areas within the yard. There were also smaller pieces of recyclable materials near Outfall #1. See Attachment C, Photo #3-4.

Description: Facing east, photo of the catch basin identified as Outfall #1. Camera Photo DSCN1173.

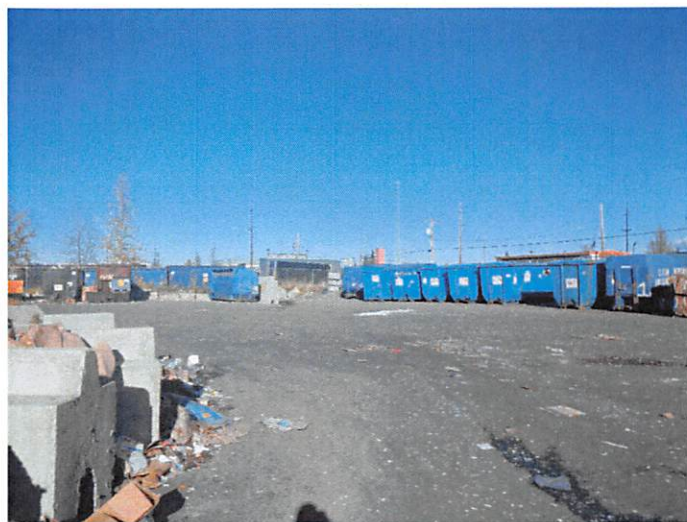
Photo #:04

Description: Facing north near the processing facility, view of the truck access route and some sorting bins. Camera Photo DSCN1174.

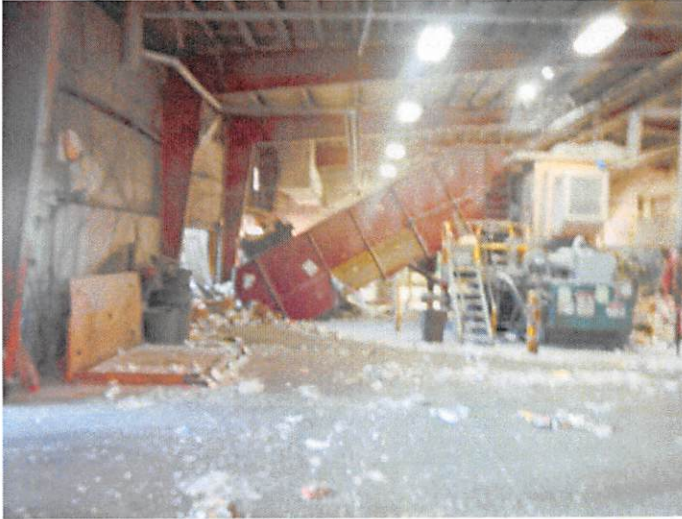
Photo #:05

Description: Photo from inside processing area. Camera Photo DSCN1175.

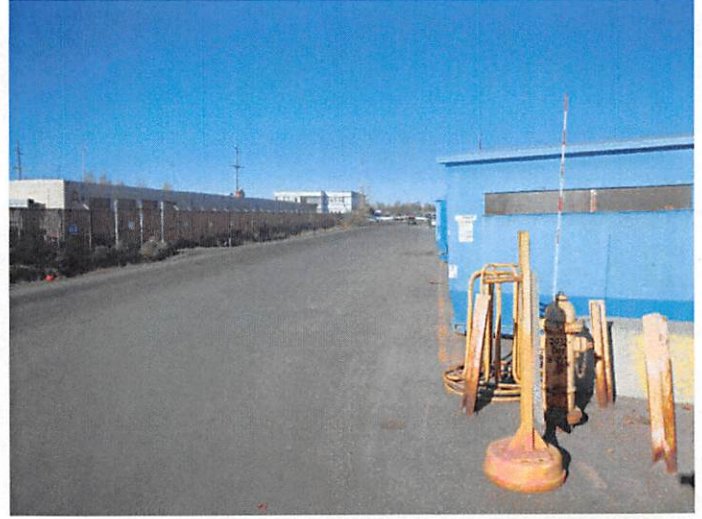
Photo #:06

Description: Facing north, photo the facility access road (Rosewood St.) Camera Photo DSCN1176.
